Inspection Report

Property Address:
19 Willow Run
SAMPLE REPORT
Birmingham, AL

ALASPEC Residential Inspections, LLC

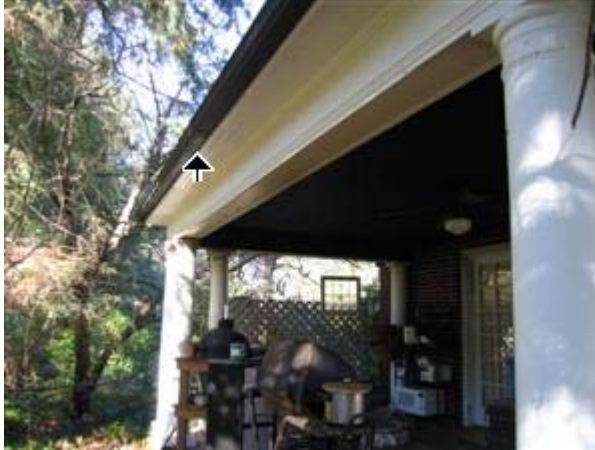
1.4 Picture 1

Gutter appears to leak at seam on covered porch at right side (facing front). Recommend cleaning and apply gutter sealant or epoxy. Gutter are peeling paint at virtually all areas where gutters are installed. Gutters are old and I did not inspect for deterioration. Recommend prep and paint using a qualified contractor.

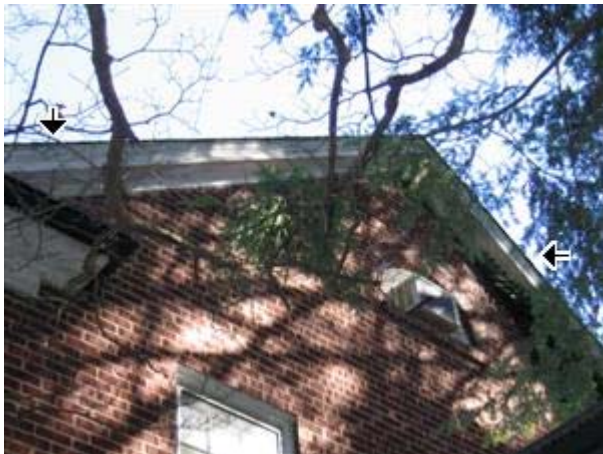
2.0 Picture 1

Comments:
Paint failing on eave. Needs prep and paint at "All" of exterior in areas.

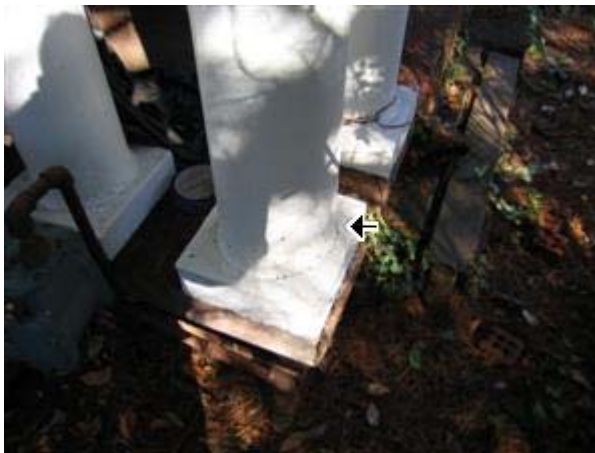
2.4 Picture 1

Support column (s) on Covered porch at right side (facing front) are weathered or lightly deteriorated in areas. This is for your information. Recommend repair as needed.

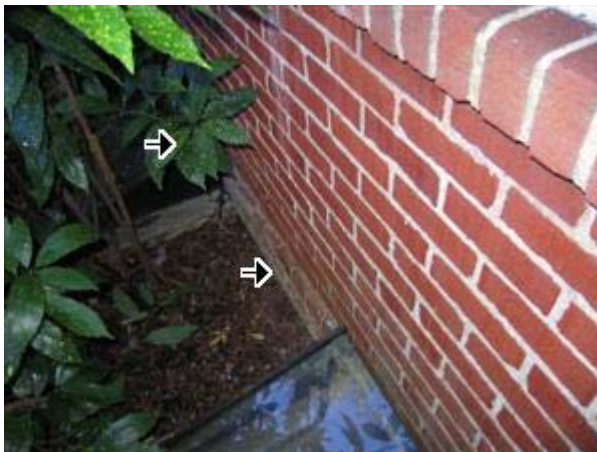
2.5 Picture 1

Brick Foundation wall at front of home and left side (facing front) has loose or missing mortar. Repairs are needed. Recommend a skilled masonry contractor perform the repairs.

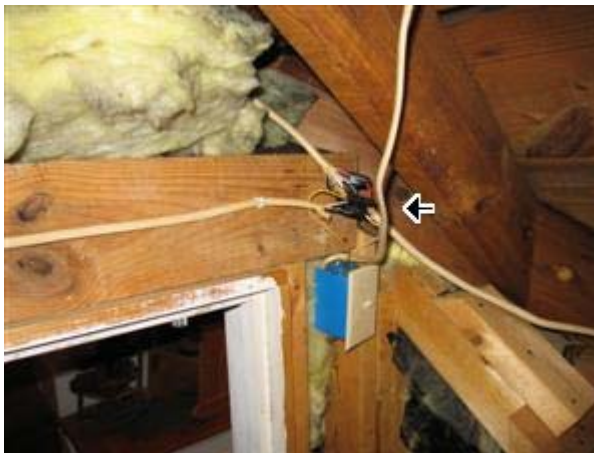
3.4 Picture 1

One loose wire splice needs placing inside a box with a coverplate within "Five feet" of attic access in attic. Electrical issues are considered a hazard until repaired. Recommend a qualified licensed electrician correct.

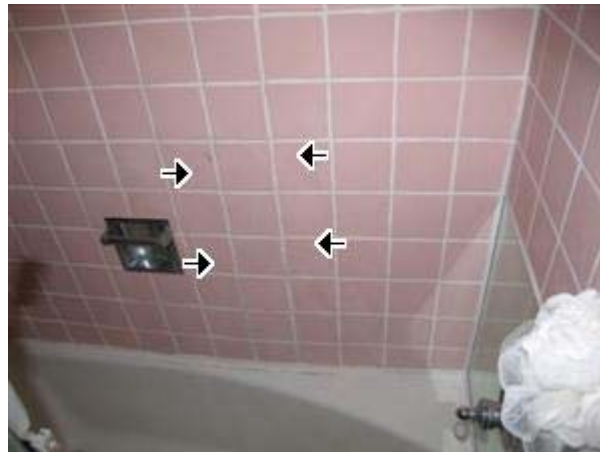
5.1.A Picture 1

Tile surround at bathtub on wall needs mortar or grout where loose at Hall Bath. Repairs are needed. Recommend a qualified contractor inspect and repair as needed.

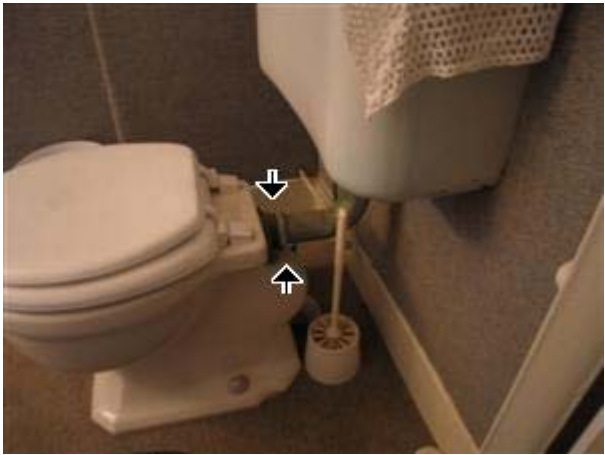
Toilet leaks at tank to toilet connection at Hall Bath. Repairs are needed. Recommend a qualified licensed plumber repair or correct as needed.

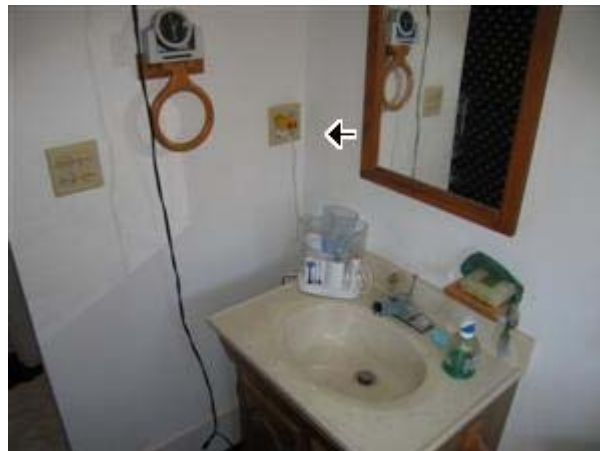
5.5.B Picture 1

"Three-prong" outlet is not grounded. Needs correcting (at upper level) in Guest bath. Electrical issues are considered a hazard until repaired. Recommend a qualified licensed electrician perform repairs that involve wiring.

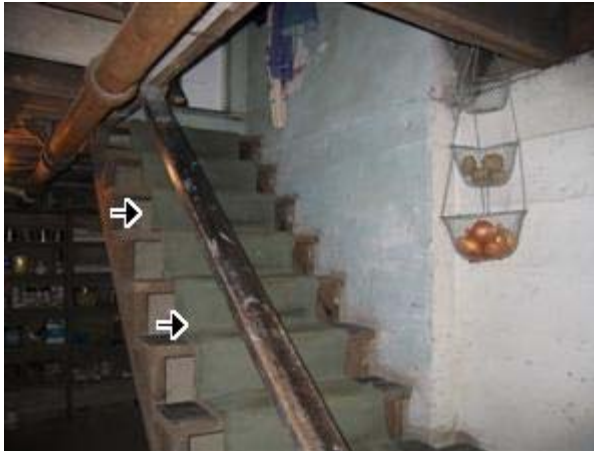
6.3 Picture 1

IN	NI	NP	MR	TR	Inspection Items
<input checked="" type="checkbox"/>	<input type="checkbox"/>	<input type="checkbox"/>	<input type="checkbox"/>	<input type="checkbox"/>	6.0 CEILINGS CEILING MATERIALS: PLASTER, CEILING TILE Comments:
<input checked="" type="checkbox"/>	<input type="checkbox"/>	<input type="checkbox"/>	<input type="checkbox"/>	<input type="checkbox"/>	6.1 WALLS WALL MATERIAL: PLASTER Comments:
<input checked="" type="checkbox"/>	<input type="checkbox"/>	<input type="checkbox"/>	<input type="checkbox"/>	<input type="checkbox"/>	6.2 FLOORS FLOOR COVERING(S): CARPET, WOOD Comments:
<input type="checkbox"/>	<input type="checkbox"/>	<input type="checkbox"/>	<input checked="" type="checkbox"/>	<input type="checkbox"/>	6.3 STEPS, STAIRWAYS, BALCONIES AND RAILINGS Comments: Hand/guard rail for stairs to basement needs proper picket spacing (4 inch max between pickets recommended) and is loose and needs tighten or repair. A fall or injury could occur if not corrected.

Recommend repair or replace by a qualified contractor.

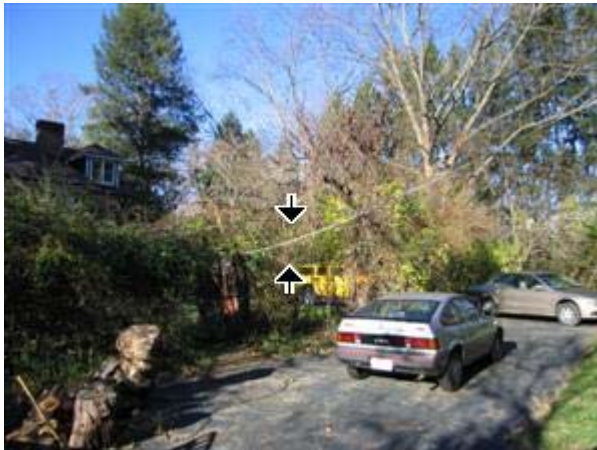
7.0 Picture 1

Comments:
 Service to garage apt is low and may need repair or replacement by an electrician.

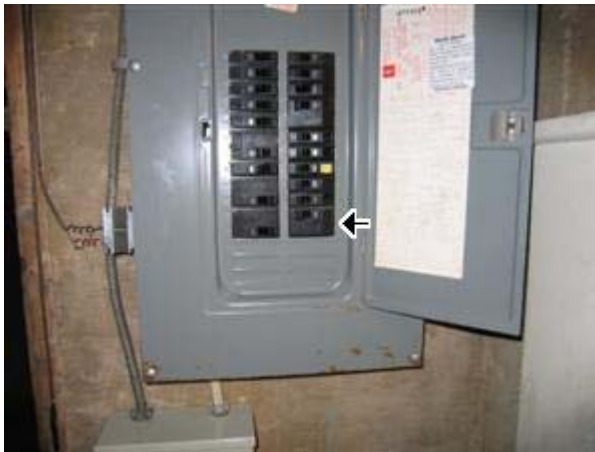
7.3 Picture 1

- 7.3 BRANCH CIRCUIT CONDUCTORS, OVERCURRENT DEVICES AND COMPATIBILITY OF THEIR AMPERAGE AND VOLTAGE
BRANCH WIRE 15 and 20 AMP: COPPER
WIRING METHODS: ROMEX, KNOB AND TUBE
Comments:
 Problem(s) discovered with Branch Circuits such as Doubled wiring at circuit(s), 12 gauge doubled into a 30 amp circuit and any other problems that an electrician may discover while performing repairs need correcting. Recommend a licensed electrician inspect further and correct as needed.

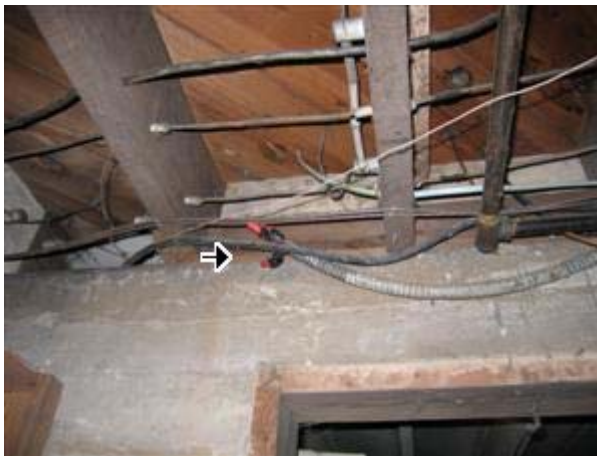
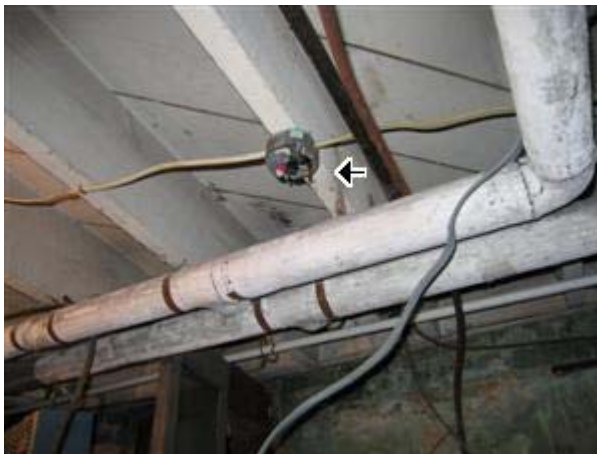
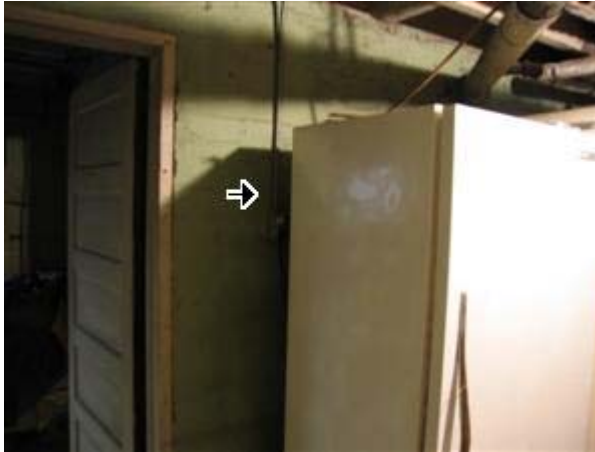
7.4 Picture 1

- 7.4 CONNECTED DEVICES AND FIXTURES (Observed from a representative number operation of ceiling fans, lighting fixtures, switches and receptacles located inside the house, garage, and on the dwelling's exterior walls)
Comments:
 Exposed splice(s) at ceiling in basement. Further inspection is needed by a qualified licensed electrician. Recommend a qualified licensed electrician correct as needed. "Three-prong" outlets are not grounded in many rooms of the home including basement. Freezer in basement is connected to a reversed polarity outlet and needs repair. Further inspection is needed by a qualified licensed electrician. Recommend a qualified licensed electrician correct as needed.

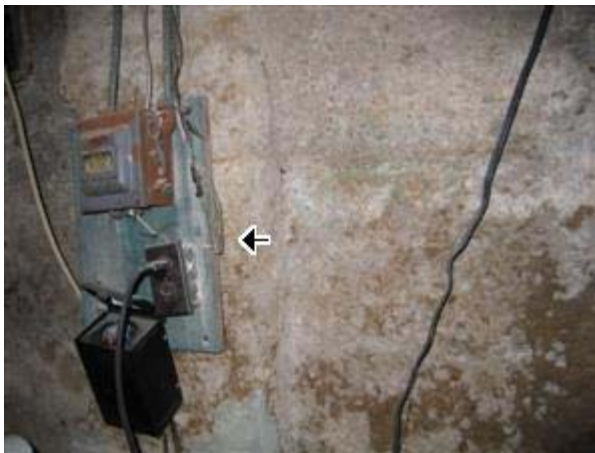
7.4 Picture 6

Electrical box and recepticle for dryer is loose.

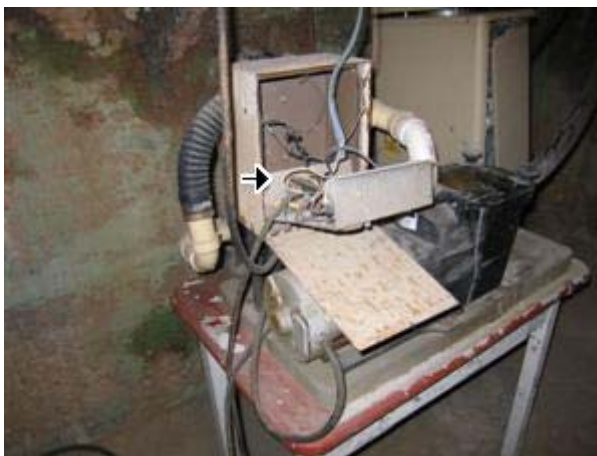
7.4 Picture 8

Pump for hot tub is wired tempory or is exposed. Electrician is needed to properly install.

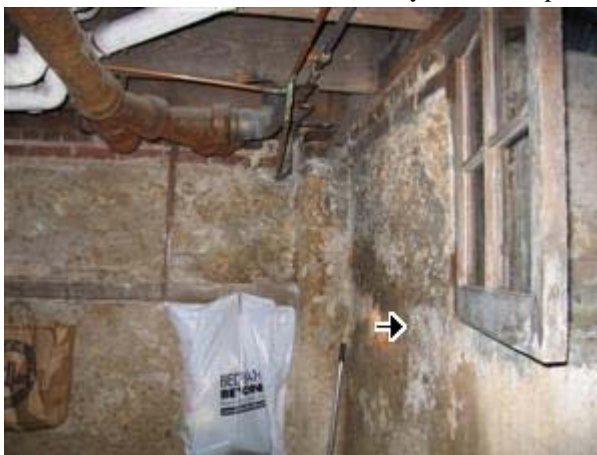
8.0 Picture 1

Foundation wall at front of home, sides and rear of home has loose missing mortar and failing. Repairs are needed. Recommend a qualified licensed general contractor inspect further and repair as needed . Recommend a skilled masonry contractor perform the repairs.

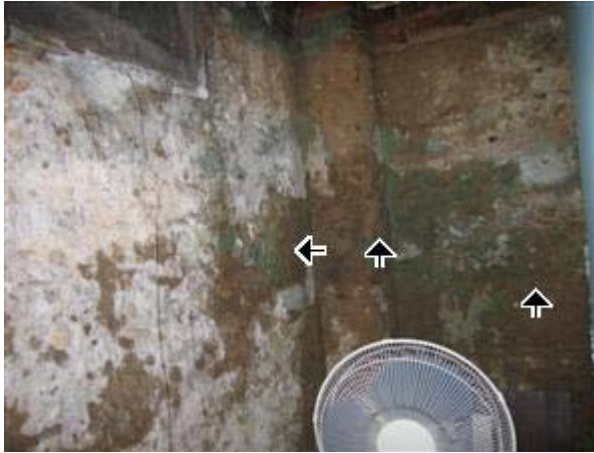
8.7 Picture 1

Visible signs of moisture intrusion in basement at left corner (facing front) and right rear corner are present from visible dampness on walls. Water intrusion can cause deterioration and excessive moisture on building components if not corrected. Recommend further investigation or correction by a qualified licensed contractor or water infiltration specialist.

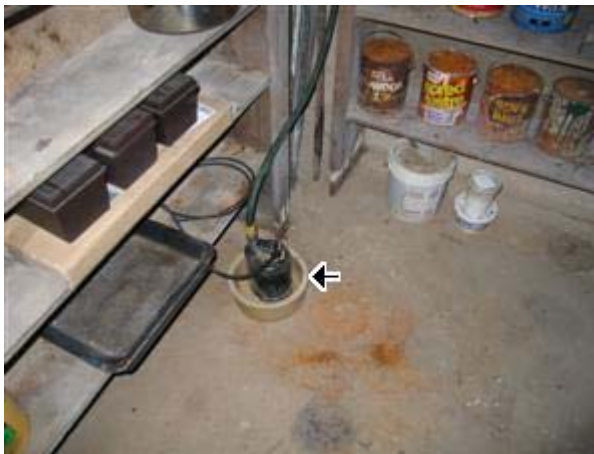
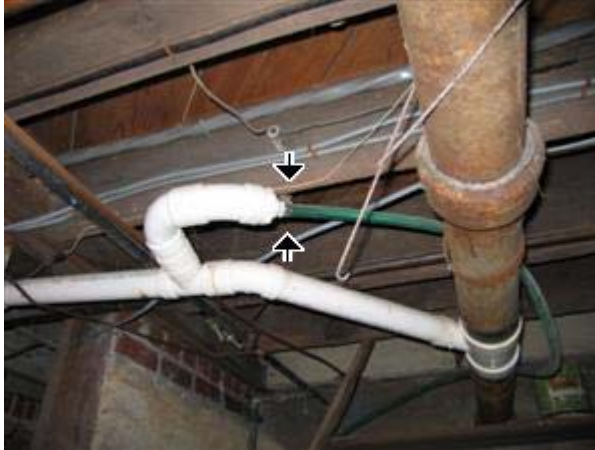
8.8 Picture 1

Sump pump in basement beside stairs appears to be used for other purpose than to be there as a water intrusion repair. Whatever its purpose, it is connected to waste line improperly and needs a plumber to correct.

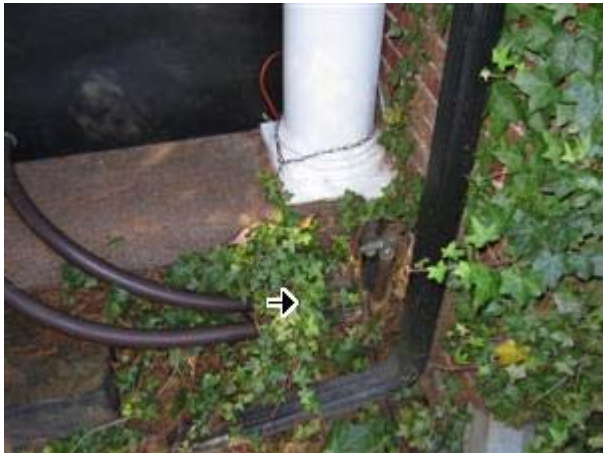
9.0 Picture 1

Comments:
 Plumbing outside at covered porch may need winterizing. I did not inspect outside HOT TUB.

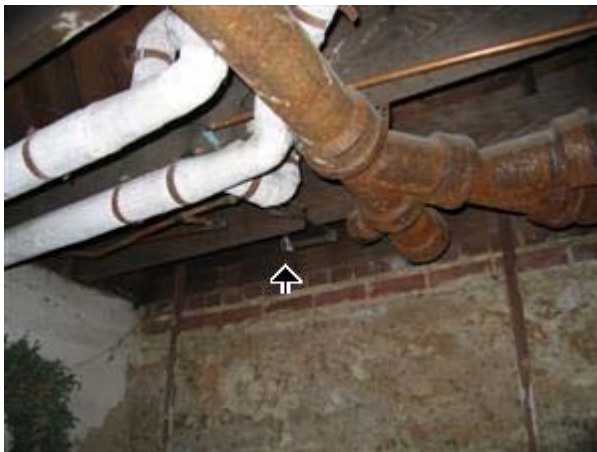
9.1 Picture 1

Corroded galvanized connection (wet joint) under half bath at stairs. This piping may become worse.

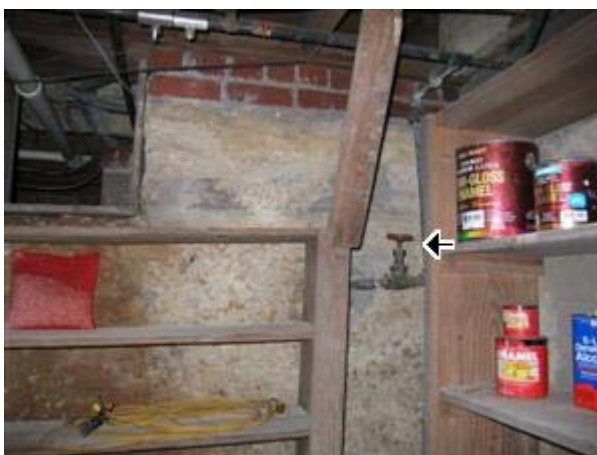
9.3 Picture 1

9.3 MAIN WATER SHUT-OFF DEVICE (Describe location)
Comments:
 The main shut off is the red knob located in basement beside stairs. This is for your information.

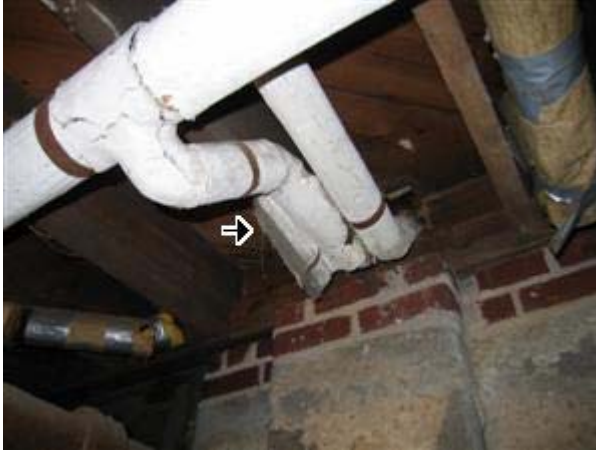
10.4 Picture 2

Wrap is loose and possible asbestos.

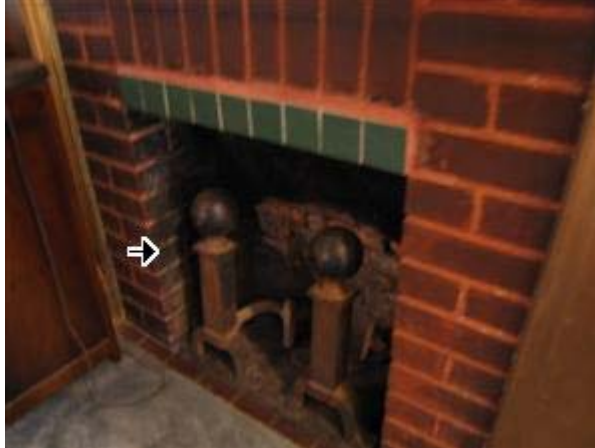
11.0 Picture 1

Bedroom fireplace is small and probably intended for coal. This fireplace is old and not considered safe until inspected by a certified chimney sweep.
